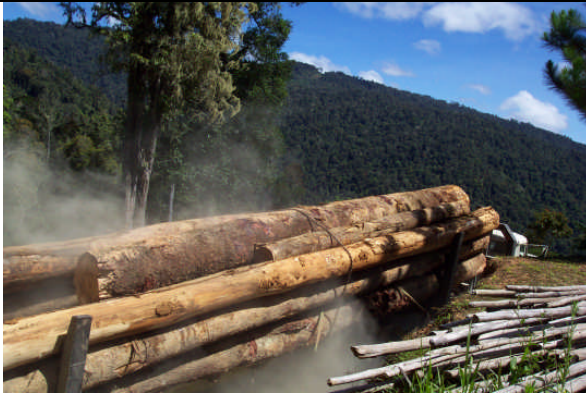
Plate 1 A loaded jincker passing the Base Camp.

This photo illustrates that fully laden jinkers are able to negotiate the narrow roads that lead to and from the Watut West TRP area.

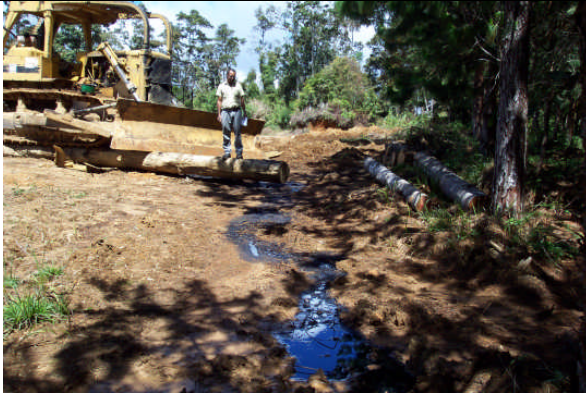
Plate 2 Sump oil drainage at the Resource Camp.

One of the few breaches of the Logging Code of Practice observed by the review team during the field visit to Watut West.

The sump oil could easily have been contained and disposed of properly.

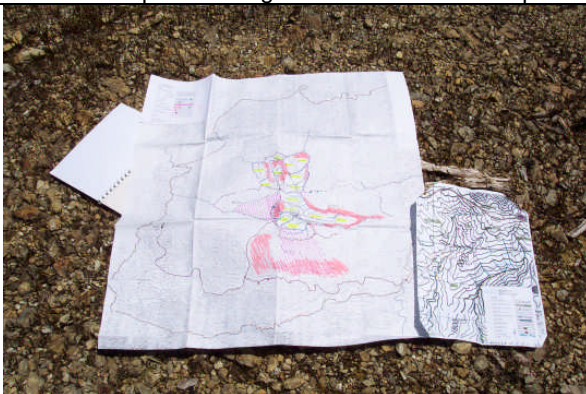
Plate 3 Annual Logging plan and Set-up Maps.

The photo illustrates the poor standard of maps provided by Bulolo Forest Products Ltd. They were very difficult to interpret.

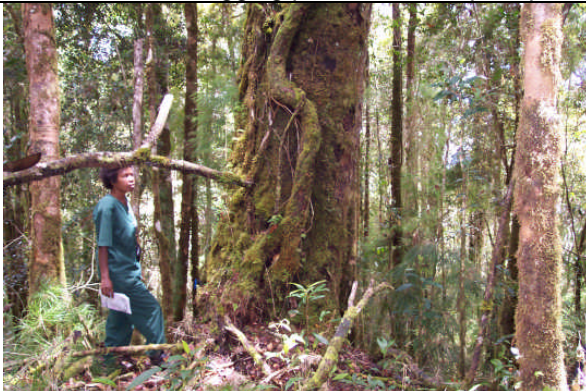
Plate 4 Breach of Key Standard 15.

This photo shows a merchantable tree that is located along a snig track. The tree is merchantable but has not been marked for felling nor have the vines been cut as required under Key Standard 5.

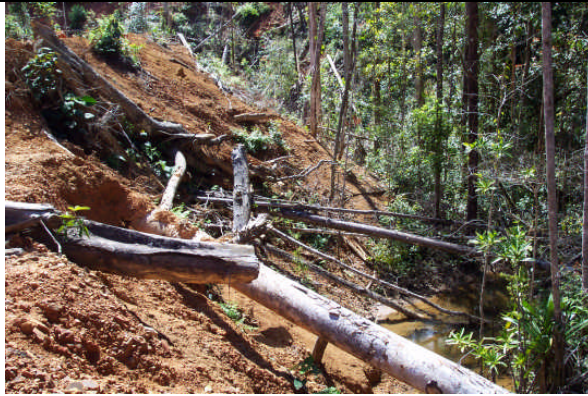
Plate 5 Excess soil and debris pushed into stream.

←The excess soil and debris pushed into this Class 2 watercourse. This has resulted in ponding.

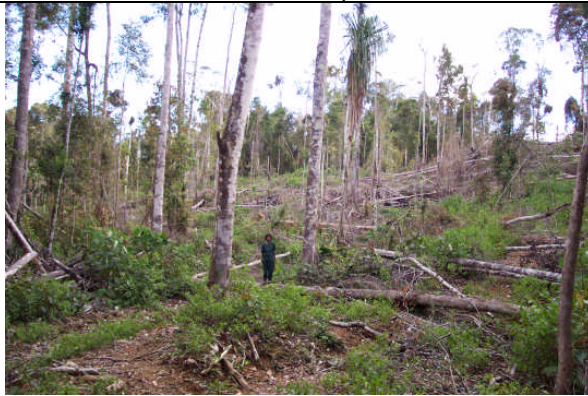
Plate 6 A large garden area in a logged set-up.

This is a cause for serious concern. There are large garden areas established both prior to and post logging in the set-ups inspected by the Review Team.

These garden areas will seriously affect the regeneration capacity of the forest.

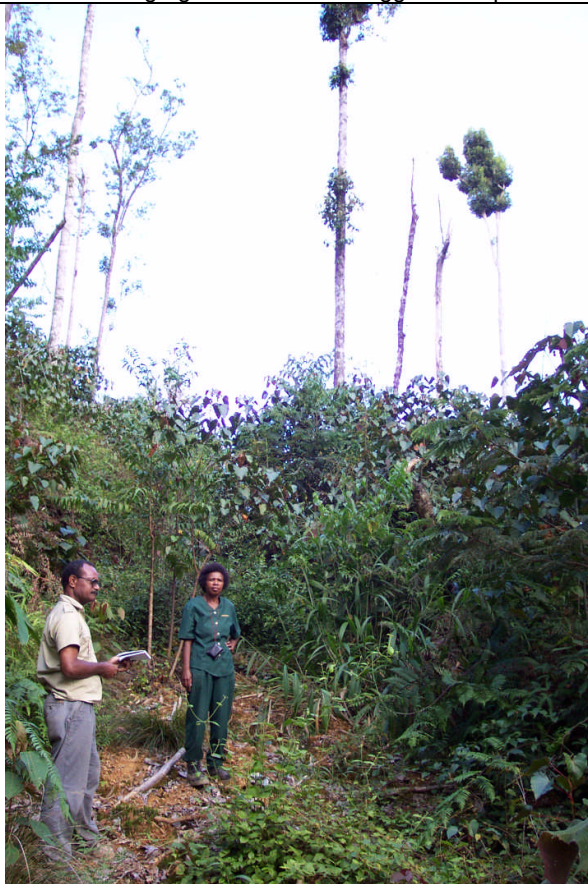
Plate 7 A snig track with good regeneration cover.

These photos illustrate that although there is good potential for regeneration of the forest after logging, provided that gardens are kept out, the species mix is dominated by non-commercial species and the area requires tending to assist the commercial species to compete and form the canopy.

The damage caused during logging to the residual stand is also very clearly illustrated and supports the need for marking of desirable residuals prior to felling.

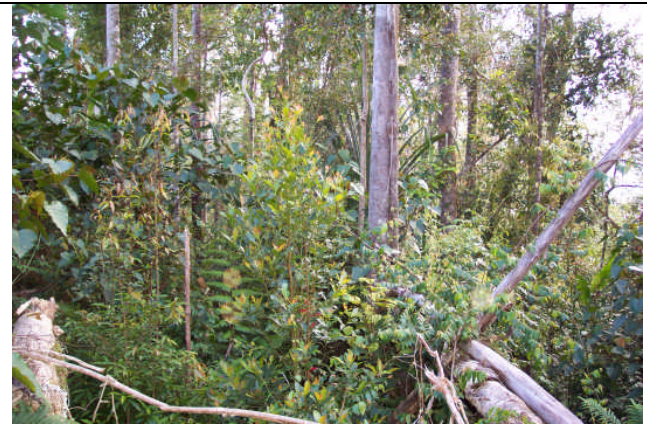
Plate 8 A mixture of species regenerating after logging. Species noted included *Eleaocarpus* spp..

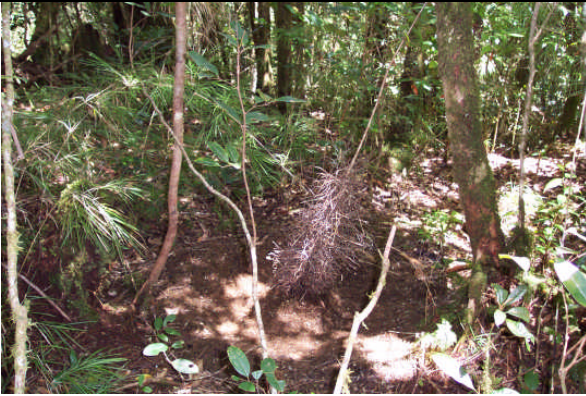
Plate 9 A bower located along a snig track.

The Review Team observed four active and one abandoned Macgregor's Bowerbird (*Amblyornis macgregorii*) bower along the snig track in Set-up 1 Block B.

Unfortunately these bowers will be destroyed during logging but if the forest is regenerated successfully the area should be recolonised by these birds.

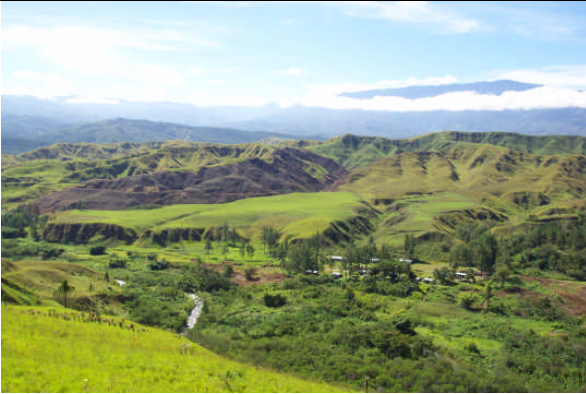
Plate 10 Fire maintained grasslands of Watut Valley.

Watut valley and Local Level Government Headquarters as seen from the Watut West TRP area.

Grassland is maintained by annual burn offs, which often destroy valuable forest plantations.

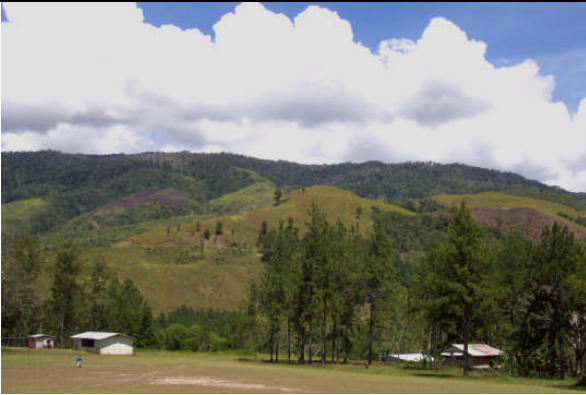
Plate 11 Fires encroaching the Watut West TRP area.

This photo shows the Watut West TRP area as seen from the Watut Local Level Government Headquarters.

Gardening and fires are destroying the edges of the forest.

Remnant pine trees indicate that forest plantations have also been destroyed by fire.

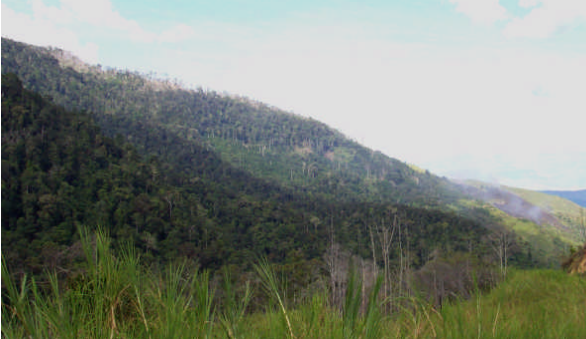
Plate 12 The Watut West forest is not immune to fire.

This photo shows fires and gardening creeping up the slopes towards the remaining forest of Watut West TRP area.

An area of forest was destroyed by fire during the "el nino" event that occurred in 2000.

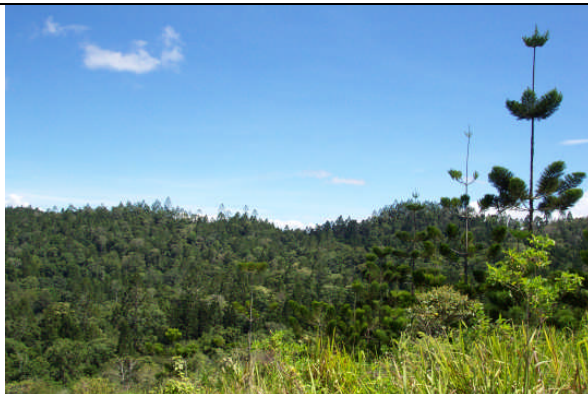
Plate 16 Regenerated forest near Bulolo.

This area of forest was logged in 1973 and allowed to regenerate. Fires have been excluded and the result is a mixed species forest dominated by *Araucaria cunninghamii* and *A. hungsteinii*. The area has been proposed as a Wild Life Management Area by the Manager of the Bulolo-Wau Forest Plantations.

If protected, the area of approximately 345 Ha would serve as a demonstration area for all stakeholders as well as students, in addition providing a fauna and flora refuge.

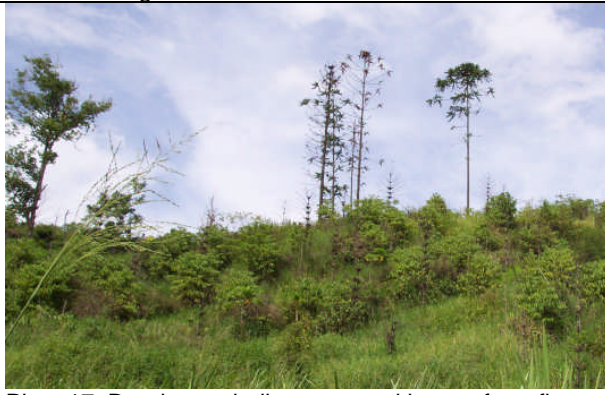
Plate 17 Dead trees indicate several losses from fire.

The Bulolo-Wau Forest Plantations are critical to the successful operation of the processing plants of Bulolo Forest Products Ltd, contributing to more than 60% of current log input.

This plantation has been destroyed by fire on two occasions and has recently been replanted.
