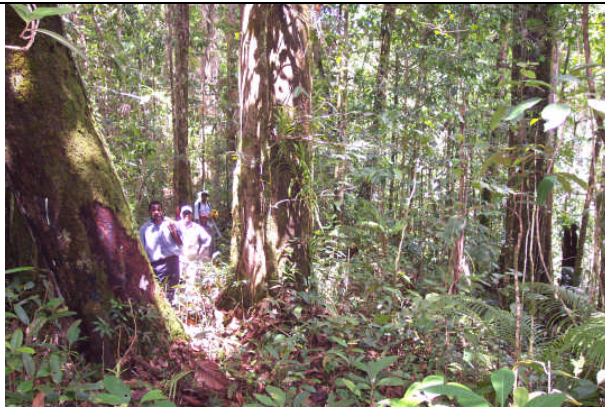
Plate 1 Dense stand of *Calophyllum* spp

This stand strides a ridge top and is along a roadline. There are six trees of merchantable size marked for felling within a 20 metre diameter circle.

The felling of all these merchantable trees will cause extensive peripheral damage even though the contractor has marked two residual trees per merchantable tree for retention.

There is provision in the Timber Permit for reservation of trees for silvicultural purposes.

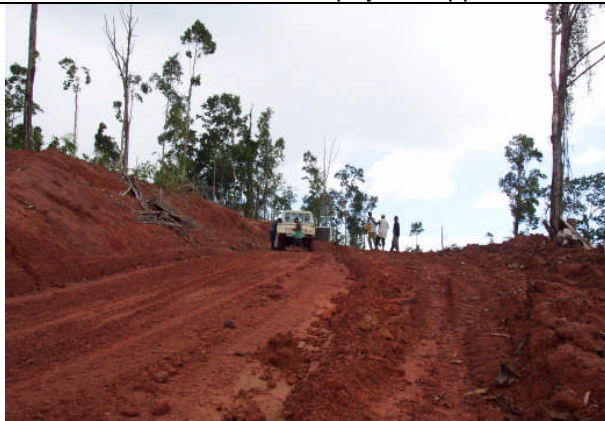
Plate 2

This is an example of excessive forest clearing during road construction (Key standard No. 9).

The surveyor explained that the original road alignment and clearing was amended to reduce the gradient of the road.

This has resulted in a total disturbance in excess of twice the permitted maximum road clearance width (40 metres).

DEC officer surveys the spoil adjacent to the road clearance. →

Soil is being washed into a watercourse.

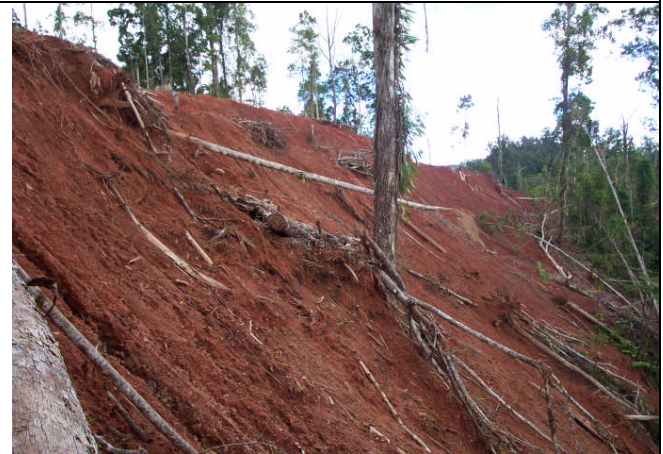
Plate 3

Plates 2 and 3 Along the main road between the Base camp and current logging area.

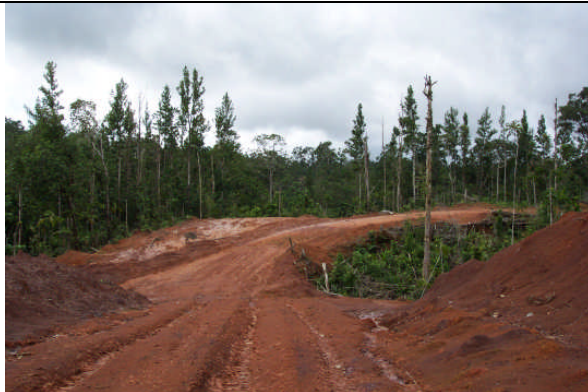
Plate 4 Main Logging road in Busou Set-up A5

This road is through a set-up which was logged just over a year ago and should have been decommissioned.

The road clearance exceeds 40 metres in some locations.

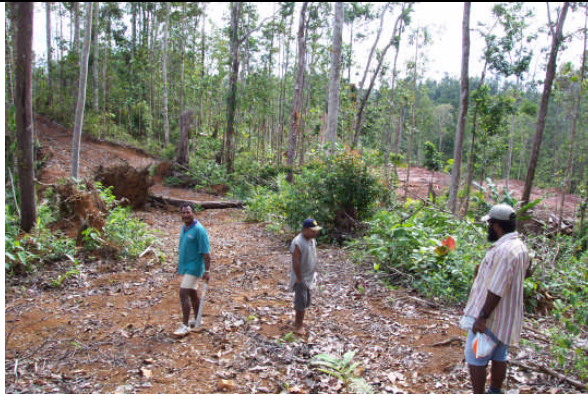
Plate 5 Set-up Busou A5

Set-up A5, one year after logging. This photo illustrates the slow colonisation of seedlings where the topsoil has been removed from snig-tracks.

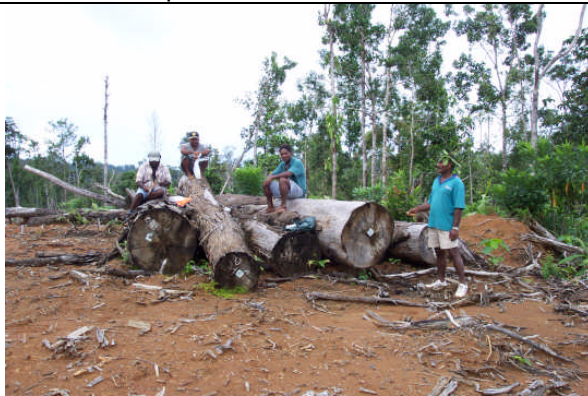
Plate 6. Set-up Busou A5

These logs have been scaled and sorted into logs suitable for the sawmill.

These logs are in a set-up which is supposed to have been decommissioned and illustrates the excessive waste of the resource.

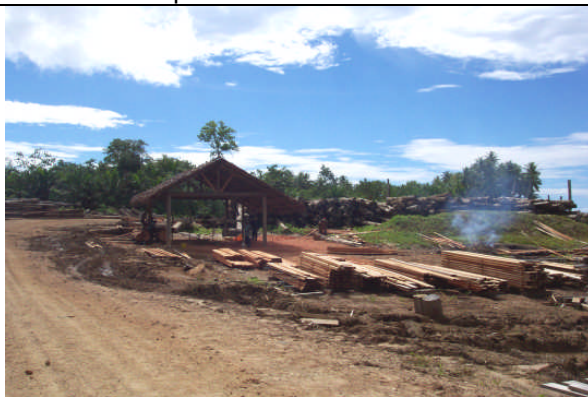
Plate 7. The Lucas Mill at the Loang Log Pond

This small sawmill owned and managed by Kei Beseu Kampani Ltd is far too small to convert the large volume of reject logs at the Loang Log Pond.

← These logs have been selected as suitable for sawmilling, many more reject logs are too degraded to be used at all.

The sawmill is producing good quality timber which is in high demand, both in Lorengau and Lae.

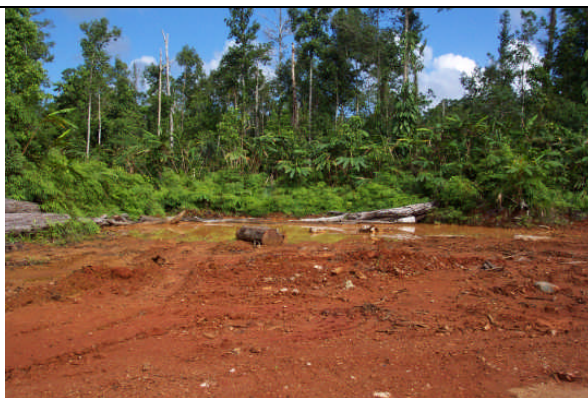
Plate 8. An old log landing.

This an example of non compliance with Key Standard No.22. Most log landings have not been ripped or satisfactorily revegetated.

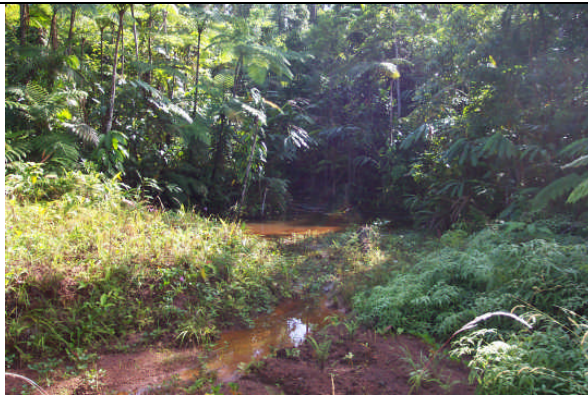
Plate 9. A blocked water course

This is an example of non-compliance with Key Standard No.10. The watercourse has been blocked by soil during road construction.

The channel should be unblocked to allow for normal flow.

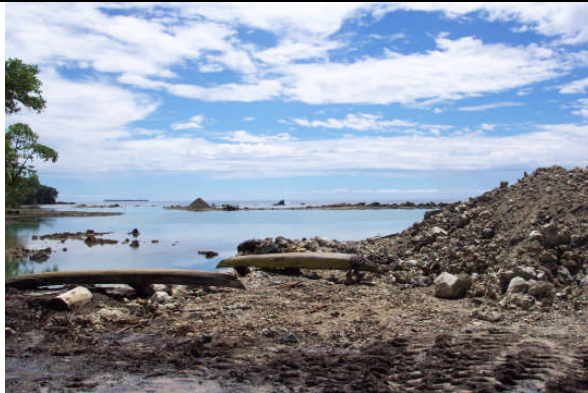
Plate 10. Excavation at the Loang Log Pond

This appears to be the only source of road surfacing material for the Timber Permit area.

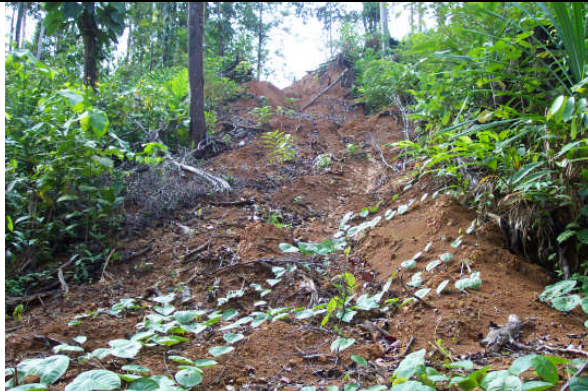
Plate 11. Busou Set-up A5

This is excessive soil disturbance resulting from snigging one tree which fell into a small dry watercourse.

Better tree felling and hauling is required to reduce this sort of damage.

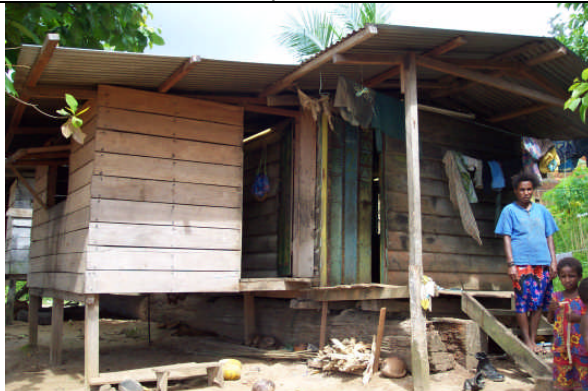
Plate 12. Substandard housing at Loang Log Pond
