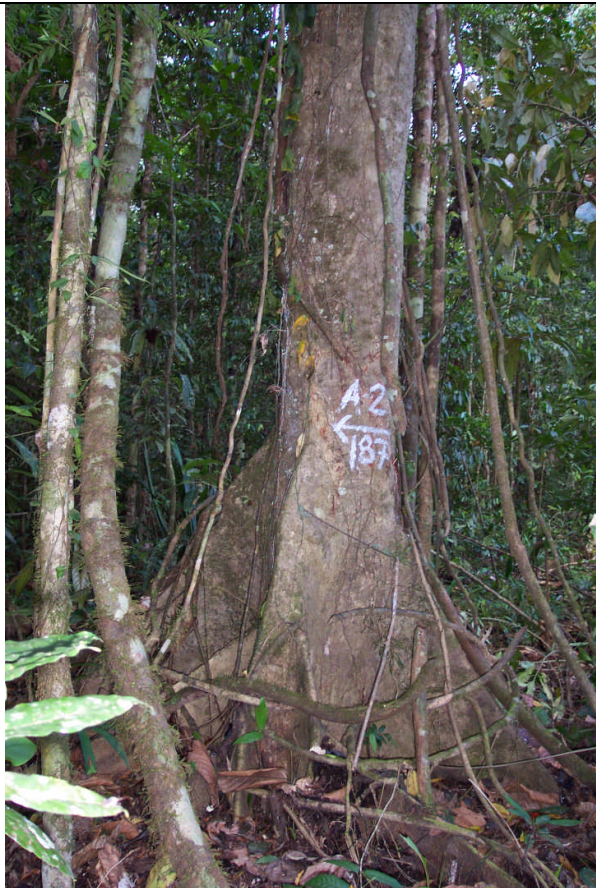
Plate 1 Tree marked for felling. Vines not cut during set-up marking (Key Standard No. 5).

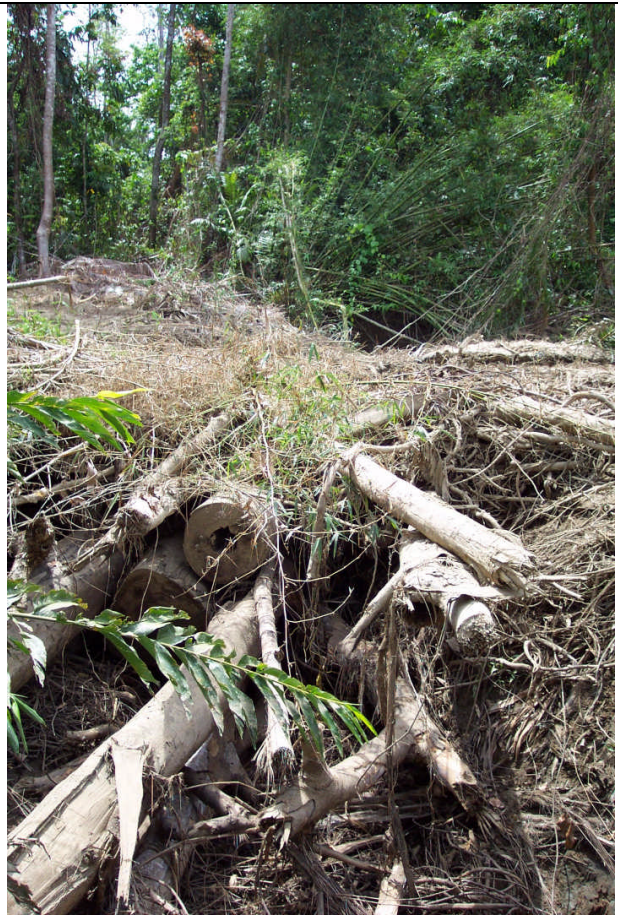
Plate 2 Log Clusters. Breach of Key Standard No. 13.

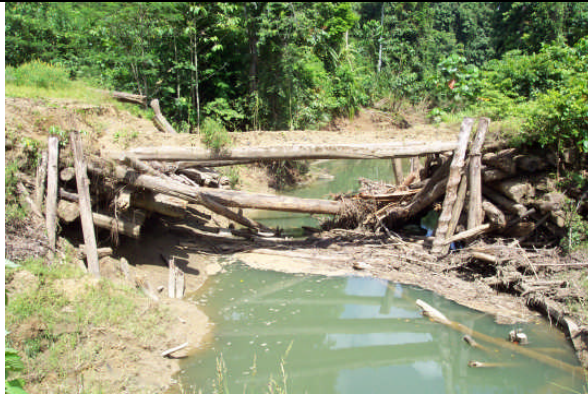
Plate 3 Old river crossing not decommissioned.

← This is an old disused bridge that should be decommissioned and debris removed from the stream to allow the water to flow freely ((Hihio River).

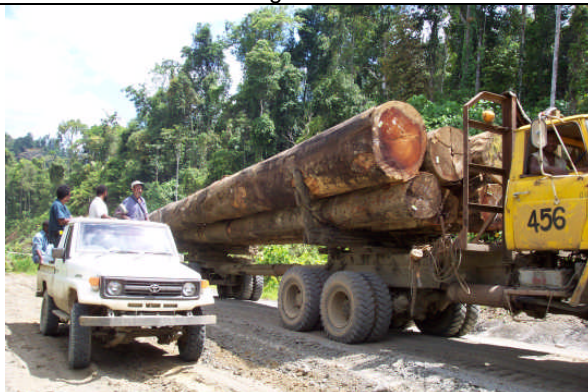
Plate 4 A fully loaded Jinker without chains.

During the field inspection on 23 rd October 2003, four logging trucks were observed to be driven without chains to secure the logs.

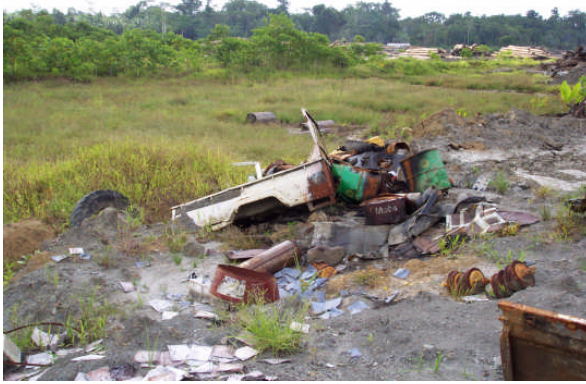
Plate 5 Exposed workshop waste.

This photo illustrates inappropriate disposal of waste at the Base Camp.

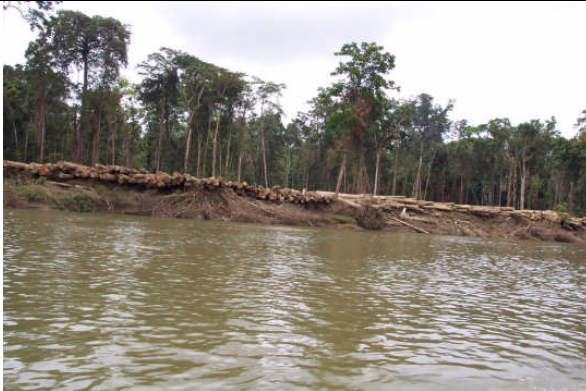
Plate 6 One of eight “River Dumps” along the Vailala River, between the Ihu station and the Hepea Base Camp (set-up SO3-04/C21).

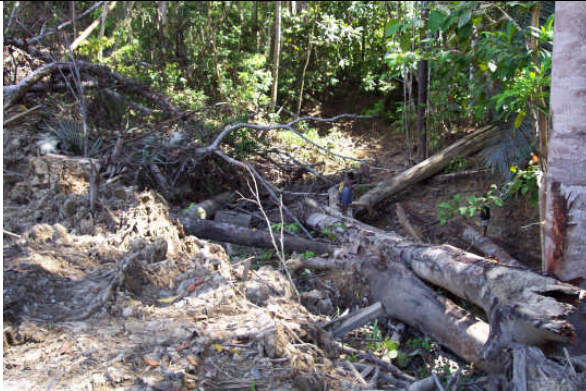
Plate 8 Excess soil and log debris in stream.

This photos shows how a bulldozer has pushed soil and log debris into a stream causing ponding in set-up 02 (contingency 02). This is in breach of Key Standard 6.

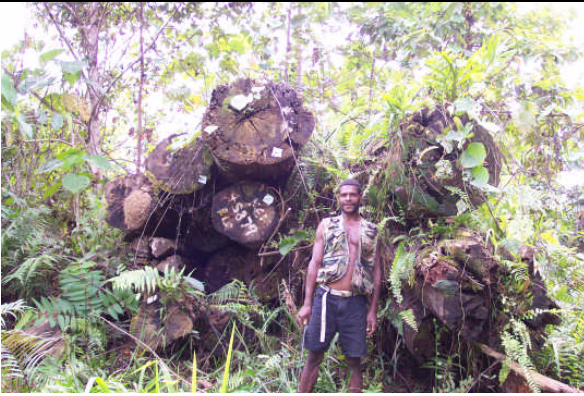
Plate 10 High quality logs abandoned to rot.

This pile of logs was abandoned after the operations in the Opoa area were disrupted. The logs have been prepared for export, tagged and left to rot (located at GPS 07°51'32" S, and 145°42'44"E).

Many more such logs were seen by the Review Team in the area either at abandoned log landings or along the roadside.

This is a considerable waste of a valuable resource and a loss of tax revenue for the national government, even if royalty has been paid to the landowners.

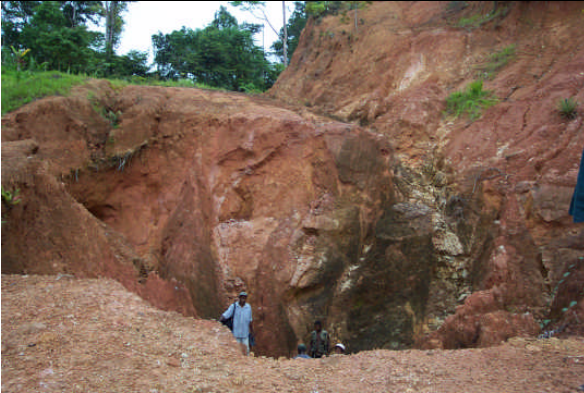
Plate 11 The Bluff-Mamuro road, a provincial highway.

This part of the Bluff to Mamuro road has collapsed due to inadequate construction standards and maintenance even though this road is noted in the Project Agreement (4.1, (b) (i), to be constructed ...to a standard which;

- (i) is equal or greater than that determined in accordance with the Department of Works Design Manual Part 2, Rural Roads for Medium Traffic Category.
- (ii) incorporates permanent materials for all drainage structure; and
- (iii) is trafficable in all weather conditions by conventional two-wheel drive vehicles.

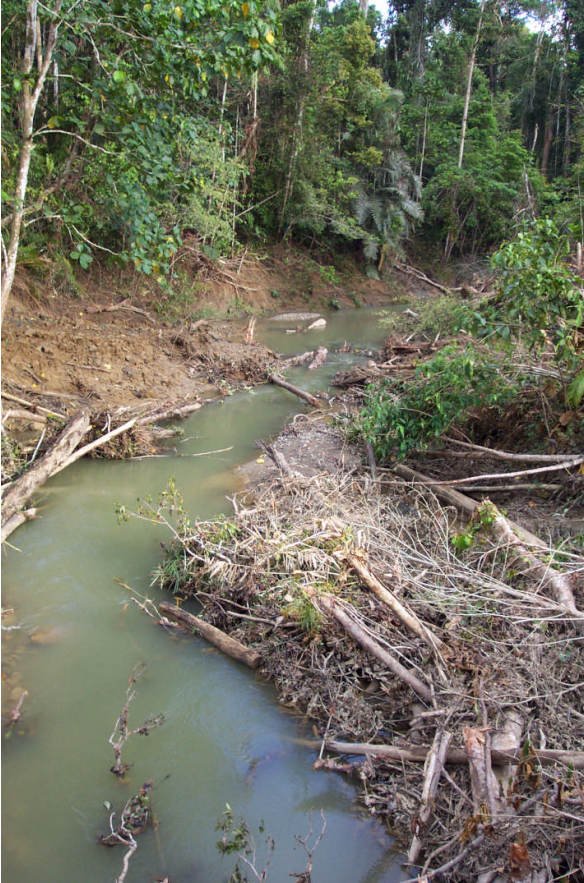
Plate 12 Breaches of Key Standards 1 and 10.

Another example of excessive disturbance to, and debris in, a Class 2 stream.
