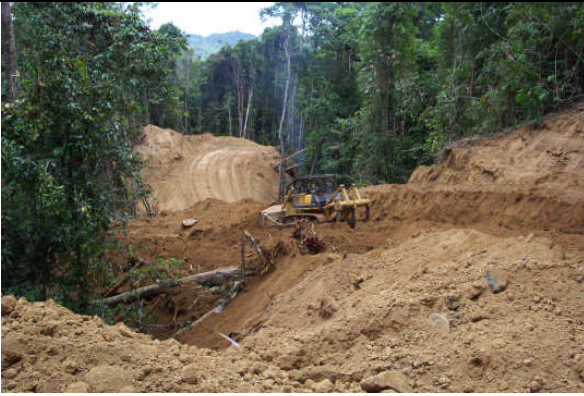
Plate 1 Road construction in contravention of court order.

This photo was taken on 27th October 2003 in an area being prepared for new set-up approval.

The road construction was suspended on the spot, by the PNGFA Regional Inspector, as he considered that it was in contravention of the National Court Order restraining Frontier Holdings Ltd from entering and carrying out logging operations in TP 2-16, at the time of the field visit.

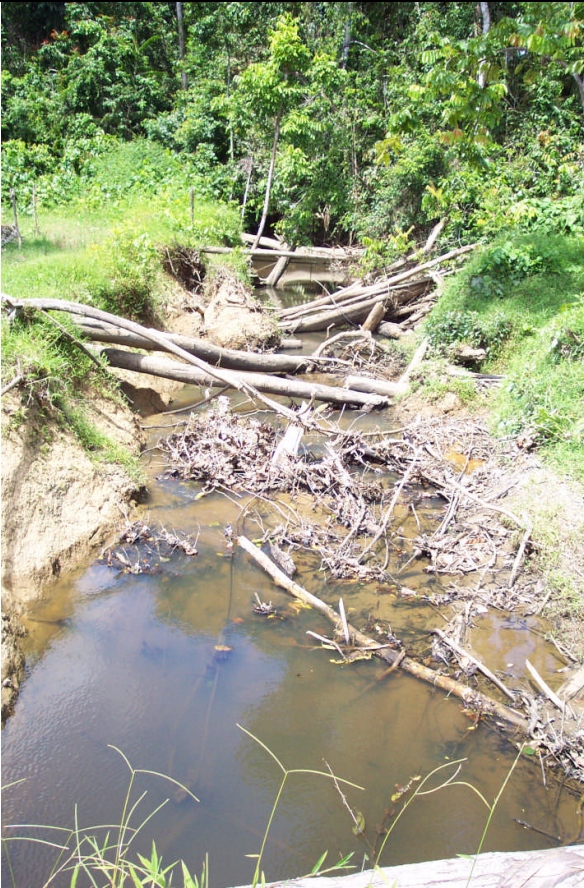
Plate 2 Breaches of Key Standards 1 and 10.

Excessive debris not removed from a Class 2 watercourse, in contravention of Key Standard 10, and buffer zones not marked (Key Standard 1).

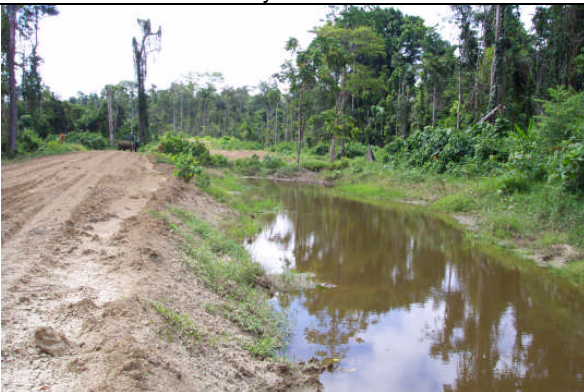
Plate 3 Lack of proper drainage causing ponding.

This photo was taken along road 12F and the lack of drainage is in breach of Key Standard 11.

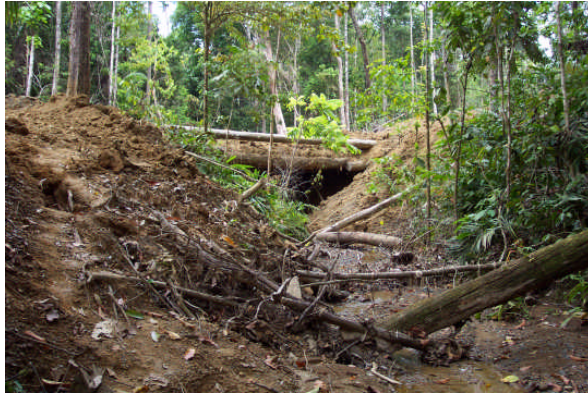
Plate 4 Breaches of Key Standards 1 and 10.

This shows a skid track inside the buffer zone of a Class 2 stream.

The photo also illustrates excessive soil and debris pushed into the waterway.

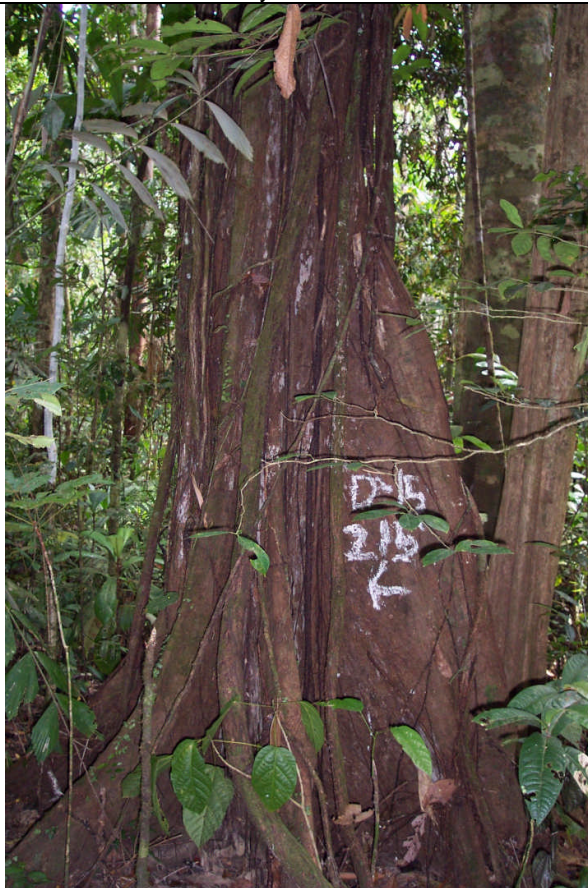
Plate 5 Vines not cut during set-up marking.

Key Standard Number 5: Cut Vines during set-up marking.

Vines should be cut all around the tree and at the same time the tree should be assessed for soundness.

This is aimed at reducing damage to the forest canopy and residual stand and to increase the safety of the feller who can stay at the tree longer to complete the scarf and backcut, and be more sure about the escape route and in which direction the tree will fall (Source: PMC Procedures).

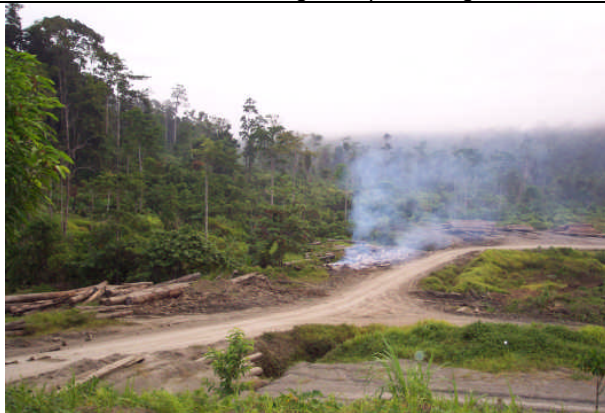
Plate 6 Burning reject Logs at Vailala Base Camp.

Export logging produces considerable waste of otherwise sound wood.

First there is the waste that is cut off at log landings during the preparation and scaling phase (see photo 7). Then, when sound logs are left too long on the log pond for whatever reason, deterioration leads to some logs being rejected by buyers.

These logs are burned.

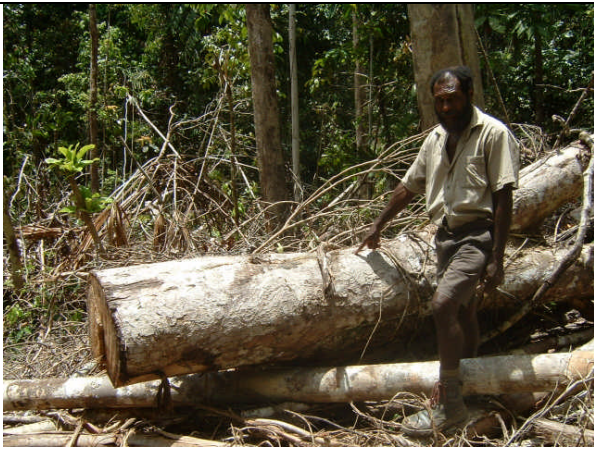
Plate 7 A metre of sound wood wasted.

An example of excessive waste. The photo shows sound wood left on the log, the export log is then measured for royalty purposes, thus landowners lose out on royalty payment.

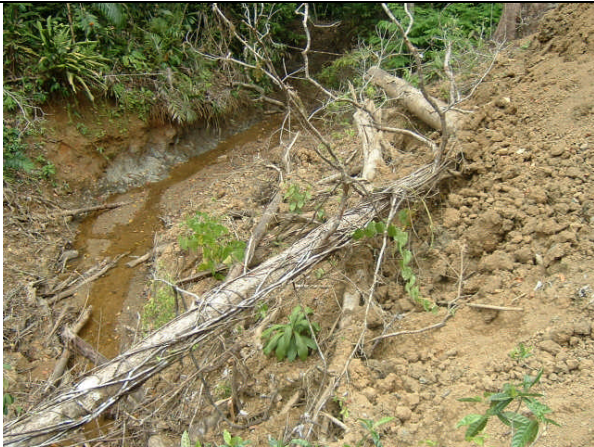
Plate 8 Excess soil and debris pushed into a Class 2 stream.

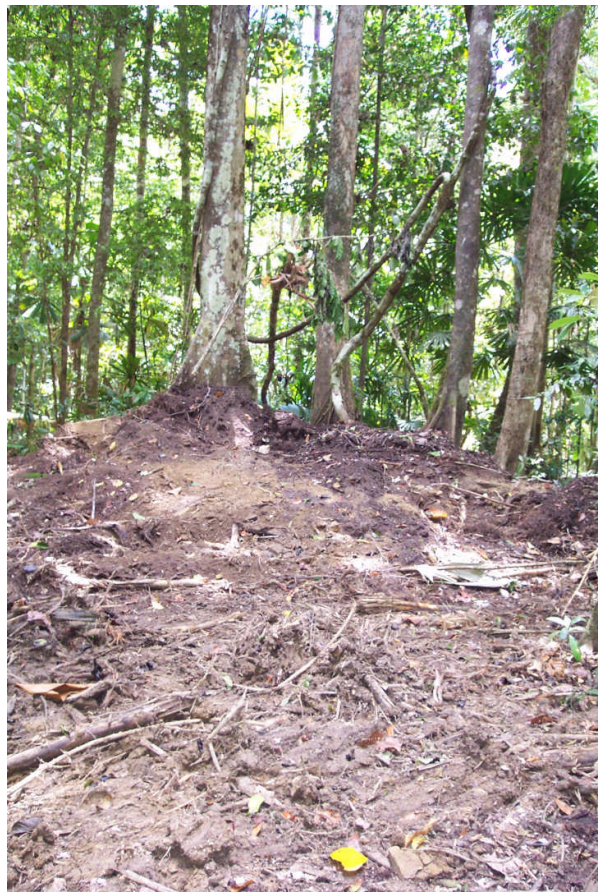
Photo 9 shows how a bulldozer has been used to harvest wildfowl eggs, thus destroying the whole nest.

This is inappropriate use of machinery and causes unnecessary damage to the environment.

Plate 9 A Wild Fowl mound destroyed by a bulldozer.
