Plate 1 Unsafe work practices, Serebi Base Camp.

Plates 2 and 3 Below illustrate the excessive trimming of logs during scaling before the logs are measured and tagged for royalty purposes. The log next to the Project Supervisor is actually marked S/M meaning suitable for sawmill and has been measured and tagged for royalty purposes. However, as there is no sawmill it is likely that this log will also be wasted. Plate 3 ↓

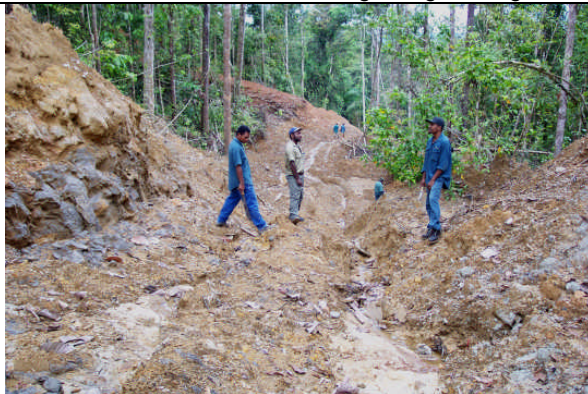
Plate 4 This is a skid track, showing excessive ground disturbance, no water bars, leading to erosion gullies.

This skid track has erosion gullies more than a metre deep, it has only just been logged and the company has requested closure of the set-up.

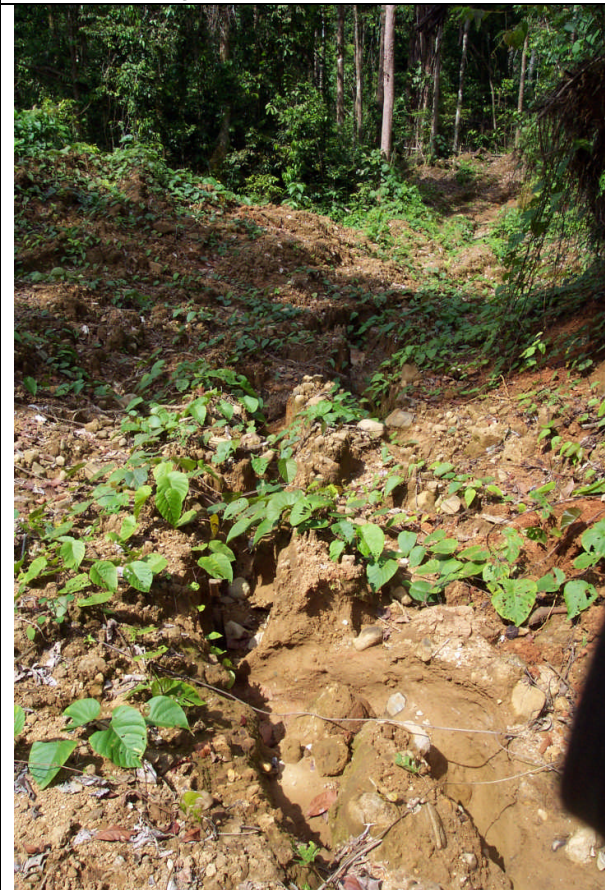
Plate 7 Erosion caused by lack of water bars.

←This photo was taken in a set-up cleared in June 2003 and shows that lack of proper water bars has caused serious erosion channels.

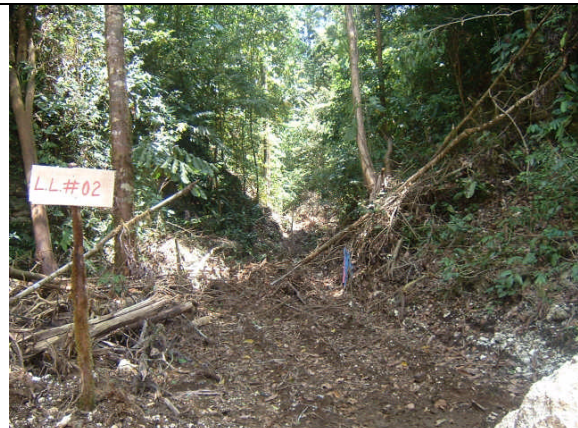
The photo below (Plate 9) shows a snig track within a karst landscape. In such landscapes location options for skid tracks is limited because of the terrain.

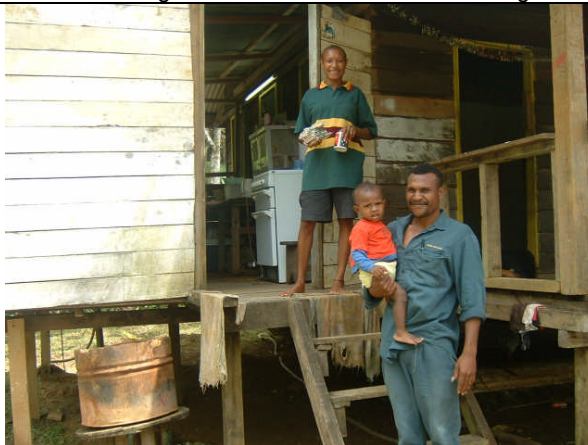
Plate 14 PNGFA Monitoring Officer and Family.

This photo show the Monitoring officer and his families living quarters provided by Turama Forest Industries Ltd at Victory Junction. The family occupies half of the house with single employees occupying the other half.

The photo illustrates the need for PNGFA staff to be housed properly by their own organization to ensure independence.
