SING AFRICA PLANTATION LIBERIA INC.

Blueyama Clan Zorzor District

Lofa County

Environmental Audit Report (EAR)

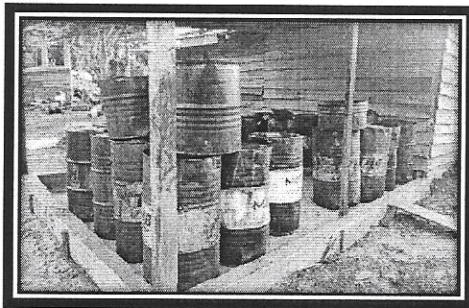
- B. Fuel Storage:** There is a storage facility for the storage of fuel and lubricant at the moment the supply of petroleum and lubricants are procured from Monrovia in bulk and transported to the project site in barrels and stored in a building or store room while a fuel tank is being constructed with concrete floor.

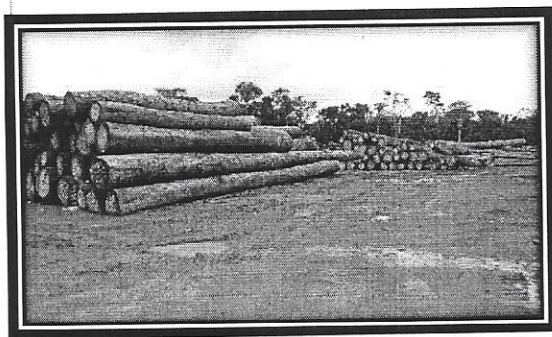
4.2.1 Logs Landings: GPS Coordinates: 29N 0412646 UTM 0858546

The team visited the landings of the company, there are two landings at the company's operational site. The site verification show there was active logging activities at these landings, but about two hundred pieces of logs were seeing at these sites. The company planned to take these logs to the saw milling that is located in the forest.
