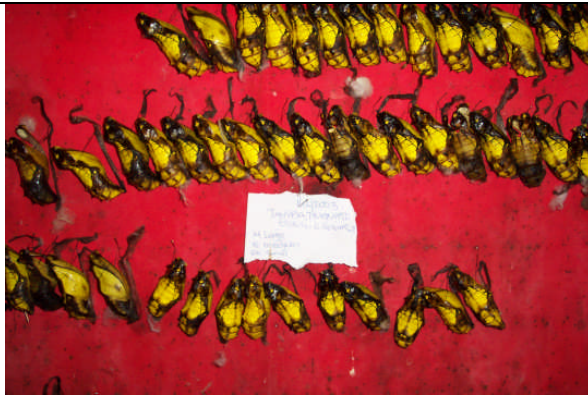
Plate 13 Pupae of the second largest butterfly in the world, *Ornithoptera Goliath*. These specimens were sent in from Gumi, a village in the Watut West TRP area.

Insect trading has been shown to successfully link habitat conservation with economic development. Regeneration of the logged over forest is essential for this trade to continue.

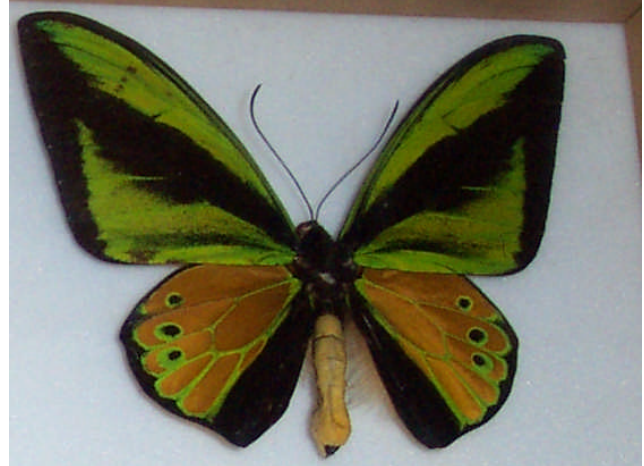
Plate 15 Display of adult male Goliath Butterfly.
