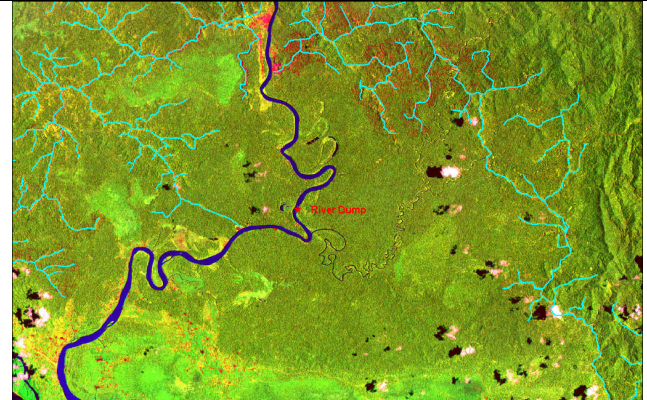
Plate 7 The location of this “dump” on a satellite photo taken in 2002. Blue lines indicate logging roads constructed up to December 2002.

Plate 6 One of eight “River Dumps” along the Vailala River, between the Ihu station and the Hepea Base Camp (set-up SO3-04/C21).

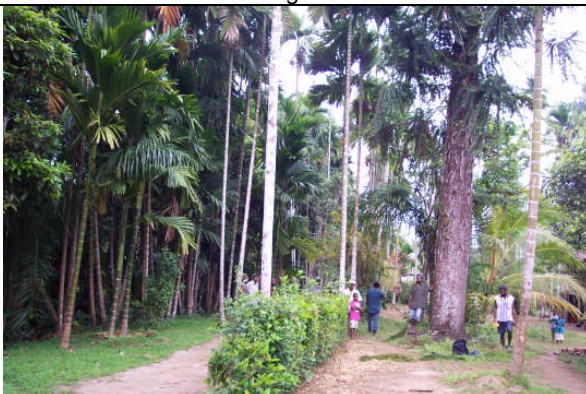
Plate 9 This Klinkii pine is over 90 cm dbh age 40 years.

This Klinkii pine (*Araucaria* spp), is estimated to be approximately 40 years old, by the son of the person who planted a few of these trees in the village of Merikera. One of the trees has been converted into sawn timber and used for construction of a house.

The photo illustrates the potential productivity of forest plantations and agricultural enterprises in the Vailala Block 1 area.
