Plate 1 Unsafe work practices, Serebi Base Camp.

Plates 2 and 3 Below illustrate the excessive trimming of logs during scaling before the logs are measured and tagged for royalty purposes. The log next to the Project Supervisor is actually marked S/M meaning suitable for sawmill and has been measured and tagged for royalty purposes. However, as there is no sawmill it is likely that this log will also be wasted. Plate 3 ↓

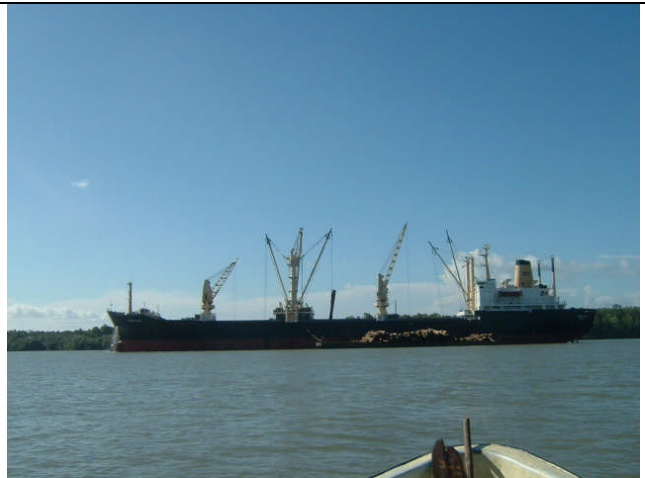
Plate 11. Loading logs at Paiai Inlet.

These photos show the generally unsatisfactory situation at Paia Inlet where water ways landowners have long complained about the deterioration to their marine resources by logging operations from which they receive little benefit.
