# ENVIRONMENTAL MANAGEMENT PROGRAM

## BAKER'S BAY GOLF AND OCEAN CLUB GREAT GUANA CAY ABACOS, BAHAMAS

ENVIRONMENTAL MANAGEMENT TEAM  
UNIVERSITY OF MIAMI AND COLLEGE OF BAHAMAS

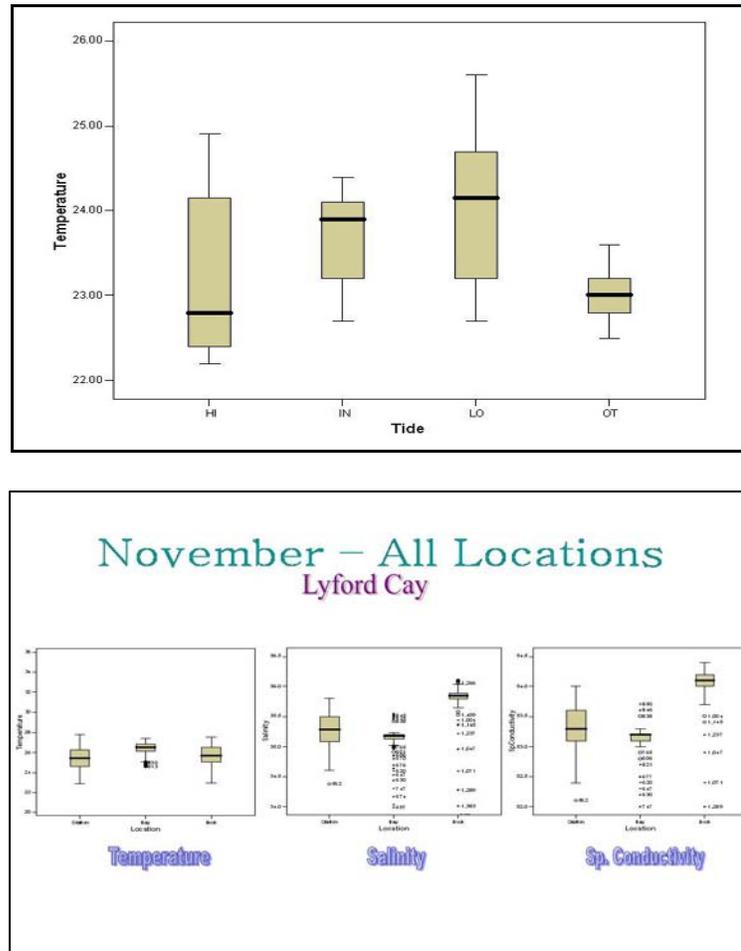
**Figure 5b. Example box plots that characterize the near shore water quality from Lyford Cay, Bahamas. These samples are taken from a relatively enclosed bay with large private homes along the shoreline. The water quality has become a concern to residents because of the overgrowth of algae, plankton blooms leading to “greenish” water, and bad smell in hot summer months. The variability of parameters such as Salinity and Conductivity can be directly tied to discharge events from private residences in this area. Examples include discharge from swimming pools and holding tanks.**

Monitoring water quality over daily, tidal and seasonal cycles will be critical for characterizing natural variability in both ground water (fresh to brackish) and the near shore marine waters. Specific monitoring will also be focused during and post marina construction. Sediment, turbidity and signs of eutrophication will be closely monitored via permanent data loggers, sediment traps and construction status reports (Section 2C). Long term data loggers produce comprehensive dataset to plot box plots (Figure 5). The larger the box, the more variability occurs at a particular site. This variability in temperature in coastal waters over a tidal cycle can be used to evaluate flushing or circulation patterns. Changes in these variability patterns come from human alterations of the island hydrological cycles and processes. Water quality monitoring and analysis will be monitored and compared to standards for the Florida Keys National Marine Sanctuary and the Southeast Environmental Research Center (<http://serc.fiu.edu/wqmnetwork/FKNMS-CD/index.htm>).

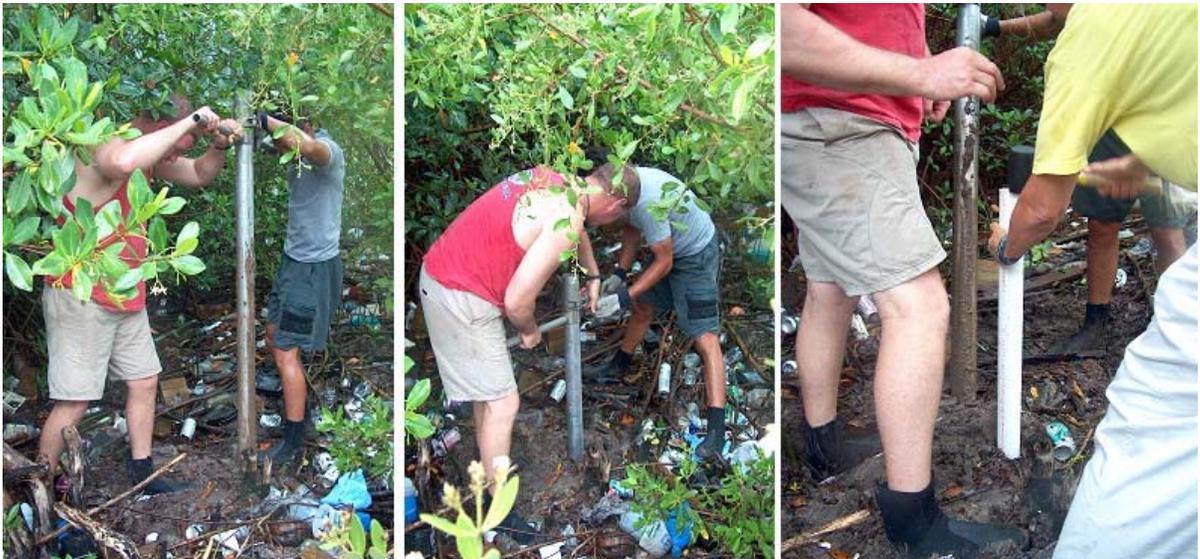
**Figure 6. Groundwater well insertion at Victoria Pond, Great Exuma. Groundwater wells are installed and then sampled to examine the flux of nutrients from the coastal zone into the near shore marine communities. Above a well is being installed in a large coastal wetland.**

Groundwater monitoring is accomplished with a YSI -85 environmental probe. On a tidal cycle sampling plan, all wells are sampled intensively for a two-week period every quarter. Additional sampling occurs after rainfall events and storms. Temperature, salinity, conductivity, dissolved oxygen and pH are recorded. Water samples are retrieved for **Particulate organic carbon (POC), Dissolved inorganic nitrogen (DIN) and Total nitrogen (TN)**. After rainfall events, **biomarkers** will be used to study flux rates of material away from the well. Groundwater sampling programs can help establish the effectiveness of landscape management practices, and detect early threats of eutrophication to nearshore marine environments.

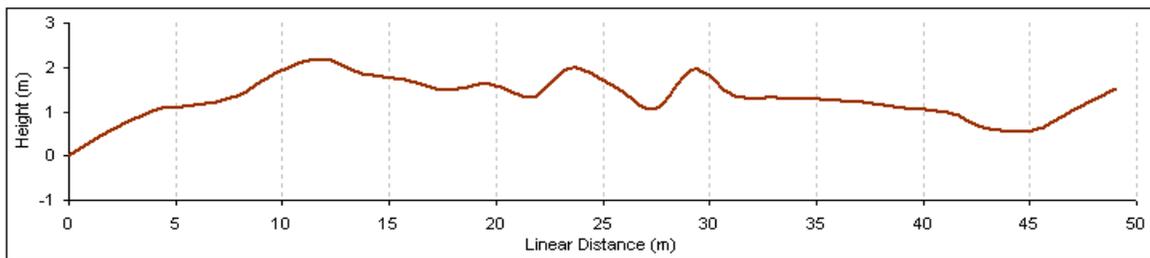
**Figure 8. An example of shoreline data collected for characterization. It shows the basic topography of Fowl Cay, which is an example of a non-altered cay. The line graph in this figure shows the varying heights of the terrain including the different zones. From the zero to the 15 meter mark is the pioneer zone, 15 to the 40 meter mark is the bluff, 40 meter to 45 meters is the ridge, 45 to 80 meters is the windward rocky bluff, and to the 90 meter mark is the rocky shore. The table is a record of the height of the points taken by the Zip level at each interval according to the height that was taken at the first point (in the figure, this is marked as 0.000; each meter mark coincides with the elevation of each point).**

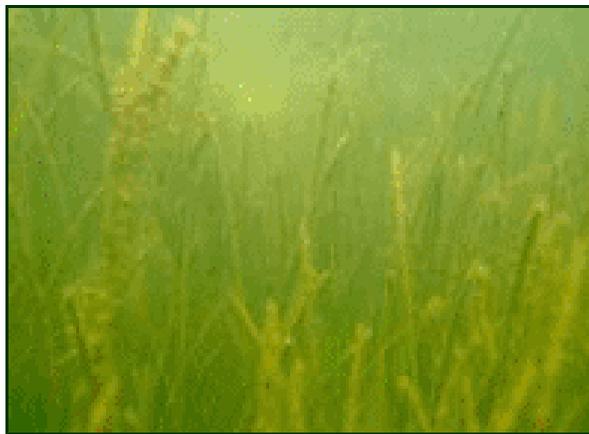
**Figure 9. A stressed and polluted seagrass bed.**

This picture shows a polluted and stressed seagrass community-typified by heavy epiphytic growth and murky water (due to sedimentation and run-off). Monitoring based on baseline conditions and tracking stressors such as sedimentation will help detect and correct run-off events.

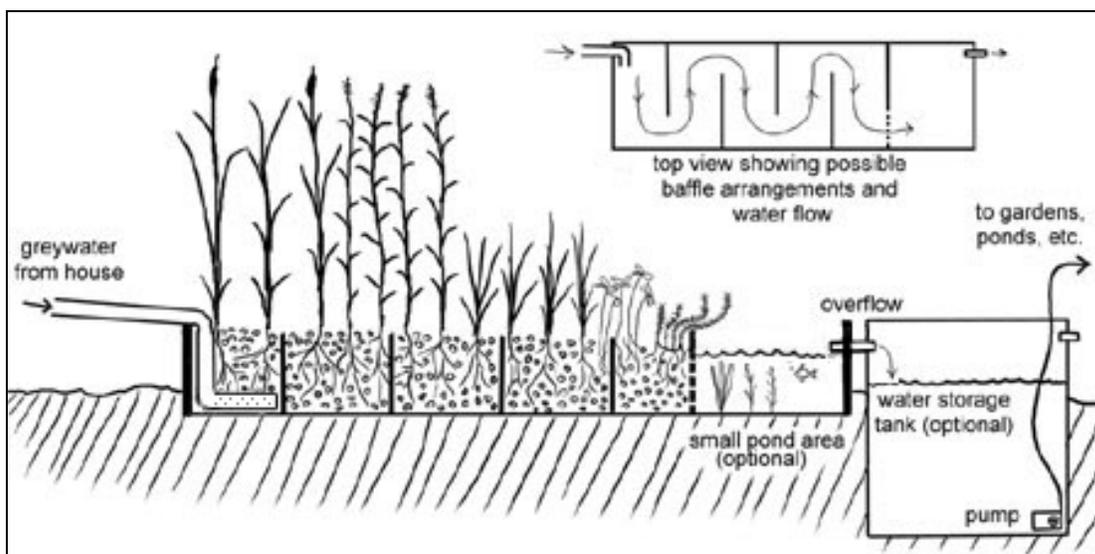
**Figure 17. Schematic diagram of a phytoremediation wetland. Copyright Lawrence Fields. Photograph by Lawrence Fields.**

It is relatively cheap and easy to build a constructed wetland. Even while becoming established, a properly designed greywater wetland will produce absolutely no bad odors or increase mosquito populations. The only difference between constructing a pond is that a natural wetland is mostly or completely filled in with some sort of growing medium for the plants (e.g gravel). The diagram below shows a basic rectangular design, with some optional "features". There is flexibility with regard to design, as wetlands themselves are generally very robust and forgiving. Wastewater wetlands can be added in a series of linked modules.

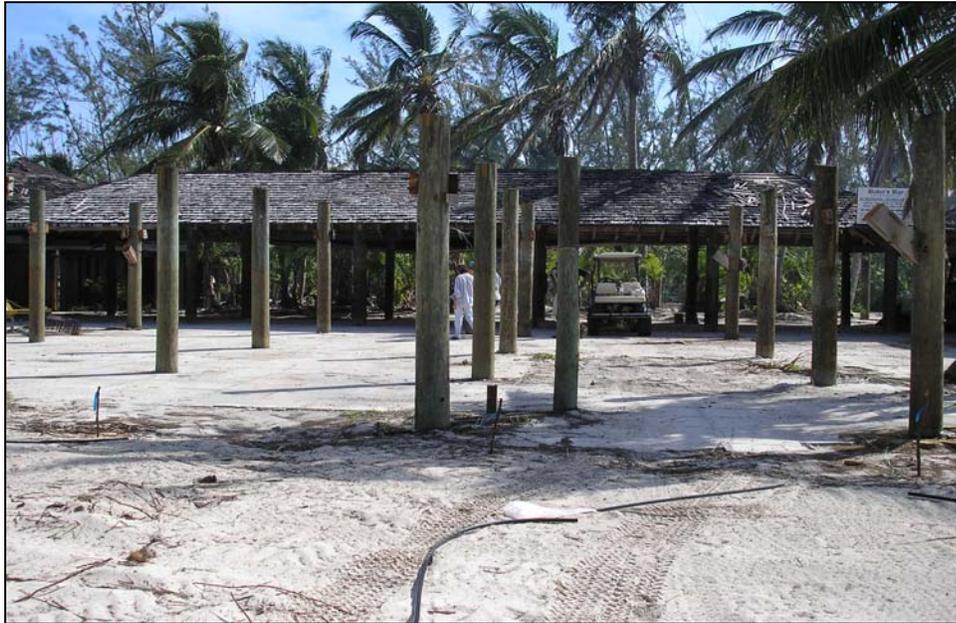
**Figure 18. Nursery site. The on site nursery will be established to transplant and salvage conservation and landscaping species. The developers have salvaged and restored structures left by a previous development for the nursery.**

The on-site nursery and management of it is a critical component of the BBC project. A goal of the EIA is to use only local vegetation, mainly from the property, for dune restoration and landscaping. Also, salvaging and replanting of conservation/rare species is vital for meeting project goals and complying with local and international regulations. Thorough documentation of species transplanted, horticulture specifics, species success rates and transplantations is important regionally and environmentally. In light of the ‘experimental nature’ of this development, the resources, efforts, and horticultural specifics used will be valuable information for understanding the specific local propagation needs for native species. This information will be documented and disseminated to local operations and homeowners to encourage native plant propagation and utilization within the Abacos. Environmentally, it is important to track water and fertilizer/herbicide/chemical use and regularly test the surrounding soils and waters to monitor for pollutants. The nursery manager and staff are responsible for the tagging of pertinent vegetation, salvaging operations, horticulture specifics (fertilizer, watering, size, growth, etc) and transplantation. **The nursery manager will keep a logbook specifying the aforementioned and submit to the EMT monthly.** Additionally, the EMT will do periodic soil testing around the nursery.
